## Effect of Inhomogeneous Distribution of Alloying Elements on Integrity of Al-2.1 wt.% Mg Alloy Tubes and Welds

Gargi Choudhuri, R Pal, P Nanekar, D Mukherjee

Quality Assurance Division, Bhabha Atomic research Centre, Mumbai, India 400085

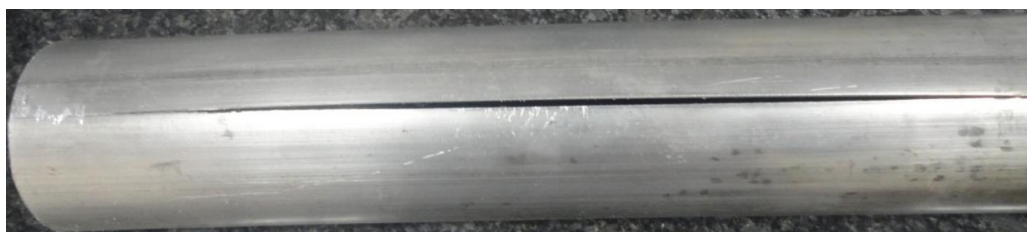
The extruded tube made by port hole die extrusion process has 2.2 mm wall thickness. These tubes are subjected to a number of cold drawing steps with intermediate annealing at 475°C for 4 hrs. to achieve the final wall thickness of 1mm. The final stress relieving heat treatment is carried out at 200 °C for 1 hr. During cold drawing (Fig.1) as well as during hydro test some tubes were found to be fractured axially along a straight line.

**Fig. 1 Opening of port hole die extruded Al- 2.1 wt.% Mg tube along the seam.**

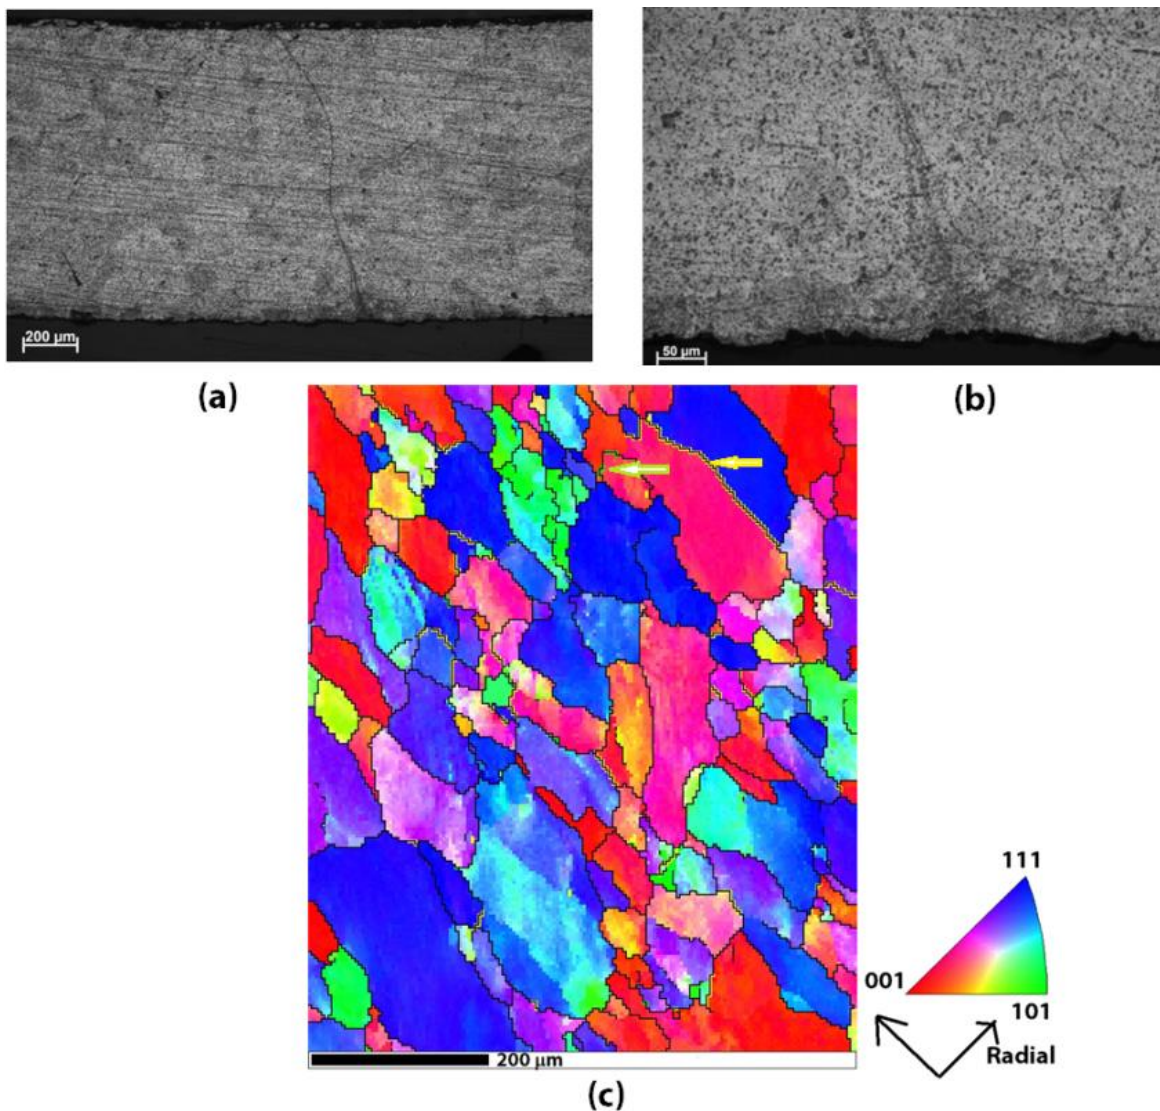
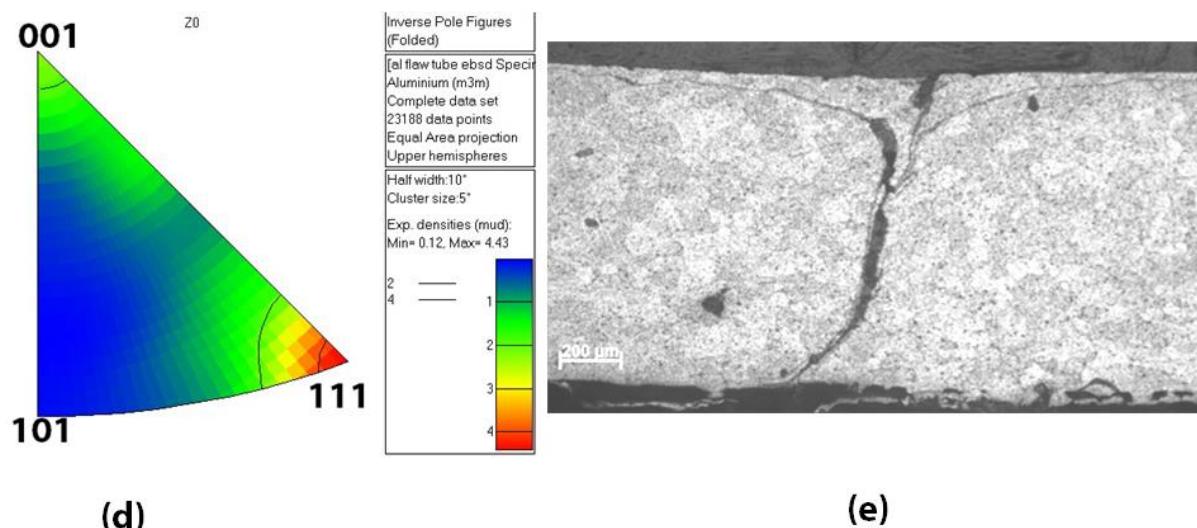
The optical micrograph of the tube that passed the hydro test indicating presence of fine line along the joint is shown in Fig.2a. The higher magnification micrograph (Fig.2b) reveals the presence of etch-pits along the weld line. These pits are due to the piling up of dislocations along the weld joint which are revealed during etching. No cracks are observed in the optical micrograph. The EBSD inverse pole figure normal to the sample surface (IPF-Z) in the cubic stereographic projection of the transverse section of the flow tube shows crystallographic orientations of different grains [Fig. 2(c)]. The grains are slightly elongated along the tube circumferential direction with aspect ratio of approximately 2. A special CSL( $\Sigma$ 3) boundaries with misorientation 60° and CSL(13b) boundaries with misorientation 27.8° are also observed in the microstructure

**Fig. 2 (a) Optical micrograph of Al-2.1 wt.% Mg tube sample passed in hydro-test showing a very fine joint line was observed at low magnification, (b) High magnification optical micrograph of tube passed in hydro-test showing etch pits along the joint, (c) The orientation image as obtained from EBSD analysis of transverse section of Al-2.1 wt.% Mg tube. (The color code represents typical grain orientation along the z direction). The special CSL $\Sigma$ 3 (60°) and  $\Sigma$ 13b (27.8°) boundaries are shown with yellow and green colored arrow, (d) The Inverse pole figure Z (surface normal) showing (111) major texture in final tube, (e) Optical microscope image of crack along the joint line in the transverse section of the tube.**

which are found to be immune to grain boundary precipitation of  $\beta$  ( $\text{Al}_3\text{Mg}_2$ ) [21] and hence should resist acid attack or intergranular corrosion [21]. The inverse pole figure (Fig.2d) normal to the surface indicates retention of deformation texture ([111] and [001]). The average hardness of the tube is HV 56.

The optical micrograph of the tube failed at the weld location (Fig.2e) shows the presence of crack along the weld line.

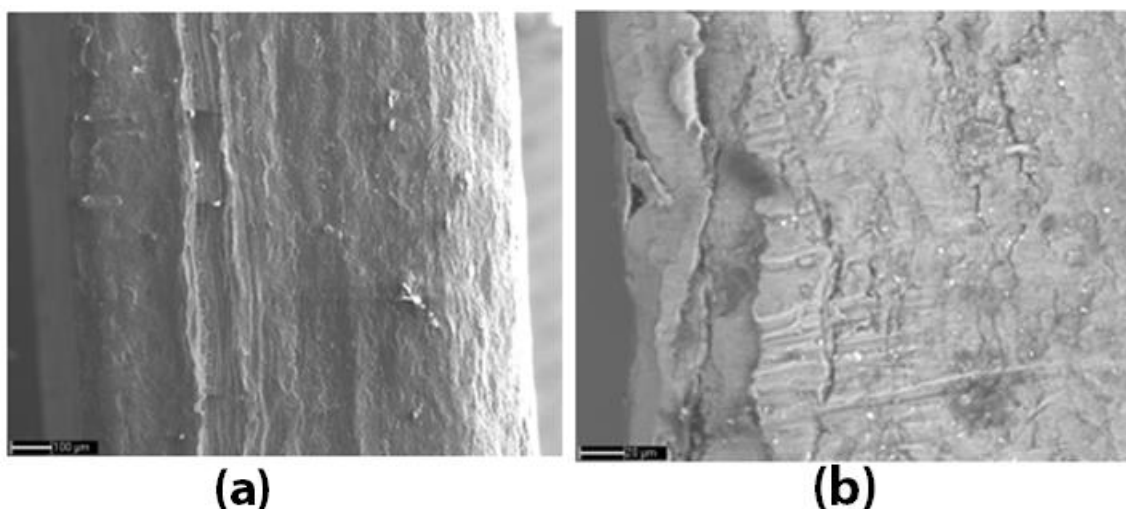
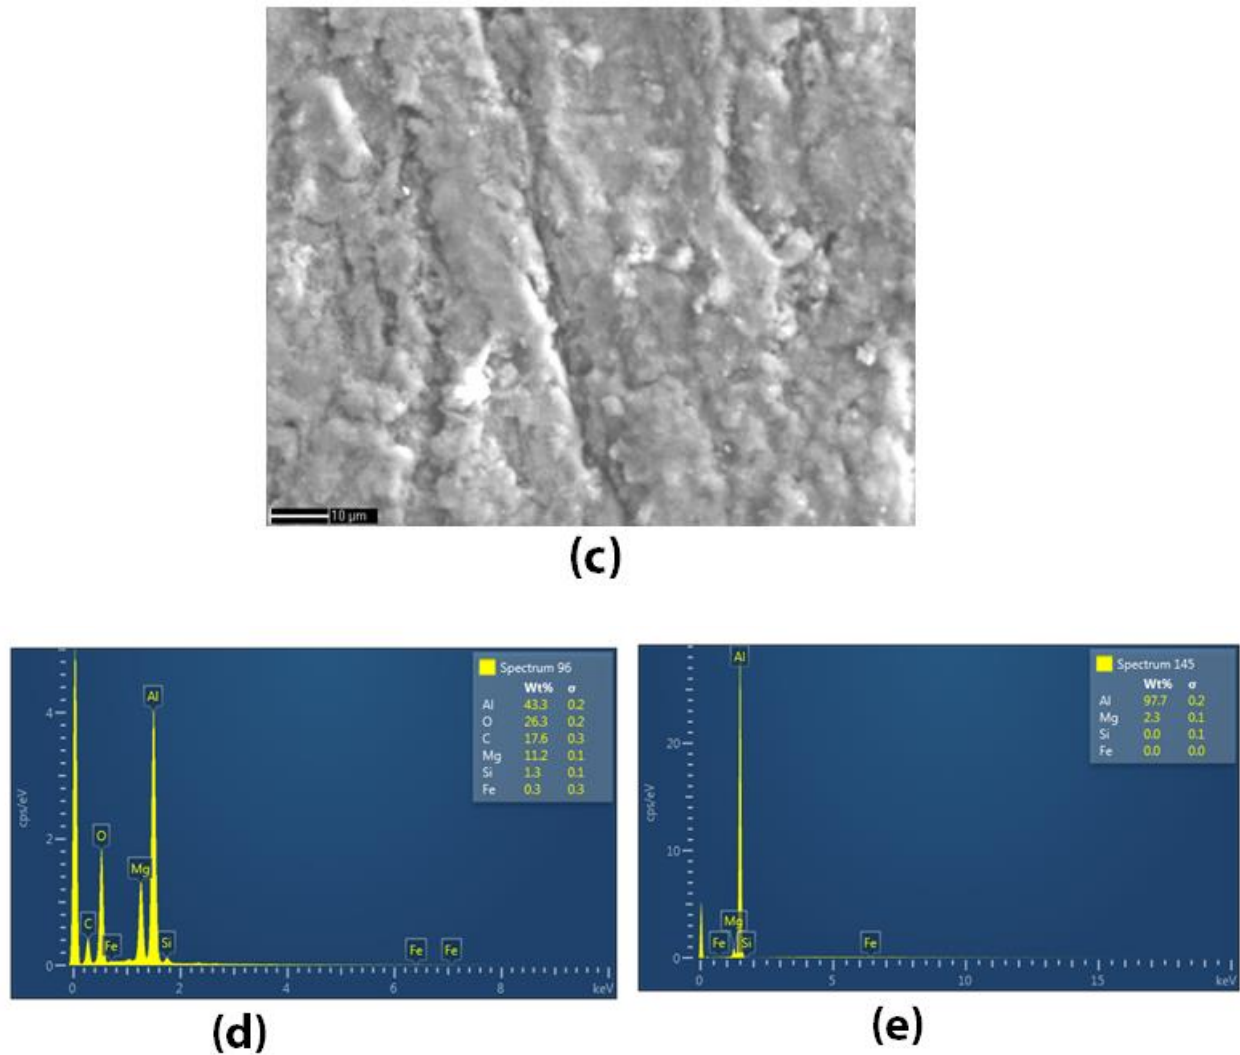
The fractured surface at the weld joint is seen in SEM (Fig.3a). Ploughing marks are seen on the surface, indicating metal flow in the extrusion direction. A higher magnification micrograph of the same surface is shown in Fig. 3b. The grains are flattened and nearly elongated in the direction of extrusion. No visible sign of gross deformation is evident from the fracture surface indicating easy separation at weld joint during the hydro test. The fracture surface is characterized by the presence of smooth features (Fig.3c) which indicates the presence of liquid at the time of fracture.

**Fig 3. SEM micrographs of fracture surface at different magnification; a) ploughing mark indicating extrusion direction, b) Flat face appearance indicating no deformation, c) presence of liquid in the fracture surface as indicated by smooth appearance of fracture surface, d) EDS pattern at 10 KV from the fracture surface and (e) EDS pattern (at 20 KV) from the weld location of the tube which pass the hydro test.**

The EDS pattern of the fractured surface (Fig. 3d) at low KV (10 KV) shows high concentration of Mg (8-19 wt.%) and Si (0.5-1.3 wt.%). The low accelerating voltage restricts the depth from which X rays are emitted, facilitates analysis of only the fracture surface region. The above ternary composition comprising of Al, Mg and Si has low solidus temperature around 500 to 530°C [22, 28] as compared to the solidus temperature of Al-2.1 wt.% Mg alloy (620°C). Hence, liquation of the regions having this ternary constituent at the weld joint area is possible during fabrication, when there is localized adiabatic heating [29] and separation occurs along this region under the presence of tensile stresses. The fracture surface also shows a high oxygen content. This may be due to the formation of oxide after fracture as the fractured aluminum surface spontaneously undergoes oxidation. The fracture surface also has high C. This C contamination may occur during handling or due to the trapped residual lubricant. Accurate determination of C in SEM is beyond the scope of SEM. Fig. 3e shows the EDS pattern of the tube at the weld location, which passed the hydro test. Contrary to the observations on the failed tube, this tube does not show high concentration of Mg (2.3 wt.%) and Si in the weld region.

From the investigations carried out it can be concluded that during port hole die extrusion process, Mg and Si rich continuous low melting metastable/equilibrium phase formation occur along the weld line due to high billet temperature and extrusion speed. Presence of low melting phase along the weld line during processing lead to formation of micro-cracks and poor quality weld joint. These micro cracks could have grown during further processing or during hydro test leading to the failure of the tube along the weld joint. The complete decoration of the weld joint with Mg, Si rich phase supports this hypothesis. The cracks gets arrested in the ductile aluminum matrix if the precipitation is not continuous.

Proper control of billet temperature and extrusion speed is utmost necessary to avoid such cracking.

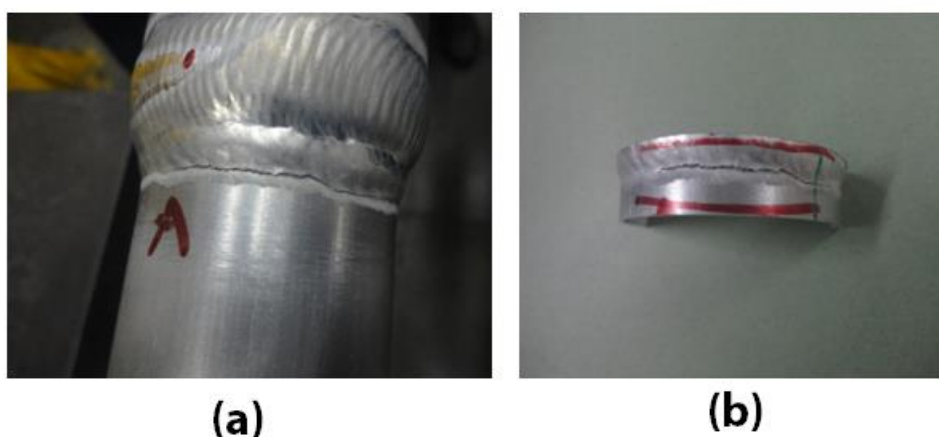
A through-wall crack is observed in the heat affected zone of the welded Al-2.1 wt.% Mg tube and tie plate assembly (Fig.4 a, b). The welding is carried out by gas tungsten arc welding (GTAW) using 2.4 mm dia. 5356 grade aluminum electrode.

**Fig 4. (a) Failure location; crack was found on the weld-parent metal interface (b) cut sample taken from for failure analysis**

Since tensile stress is necessary to cause cracking, it may be possible to avoid cracking with susceptible material by adapting the procedures which ensure presence of compressive stress at HAZ during welding.

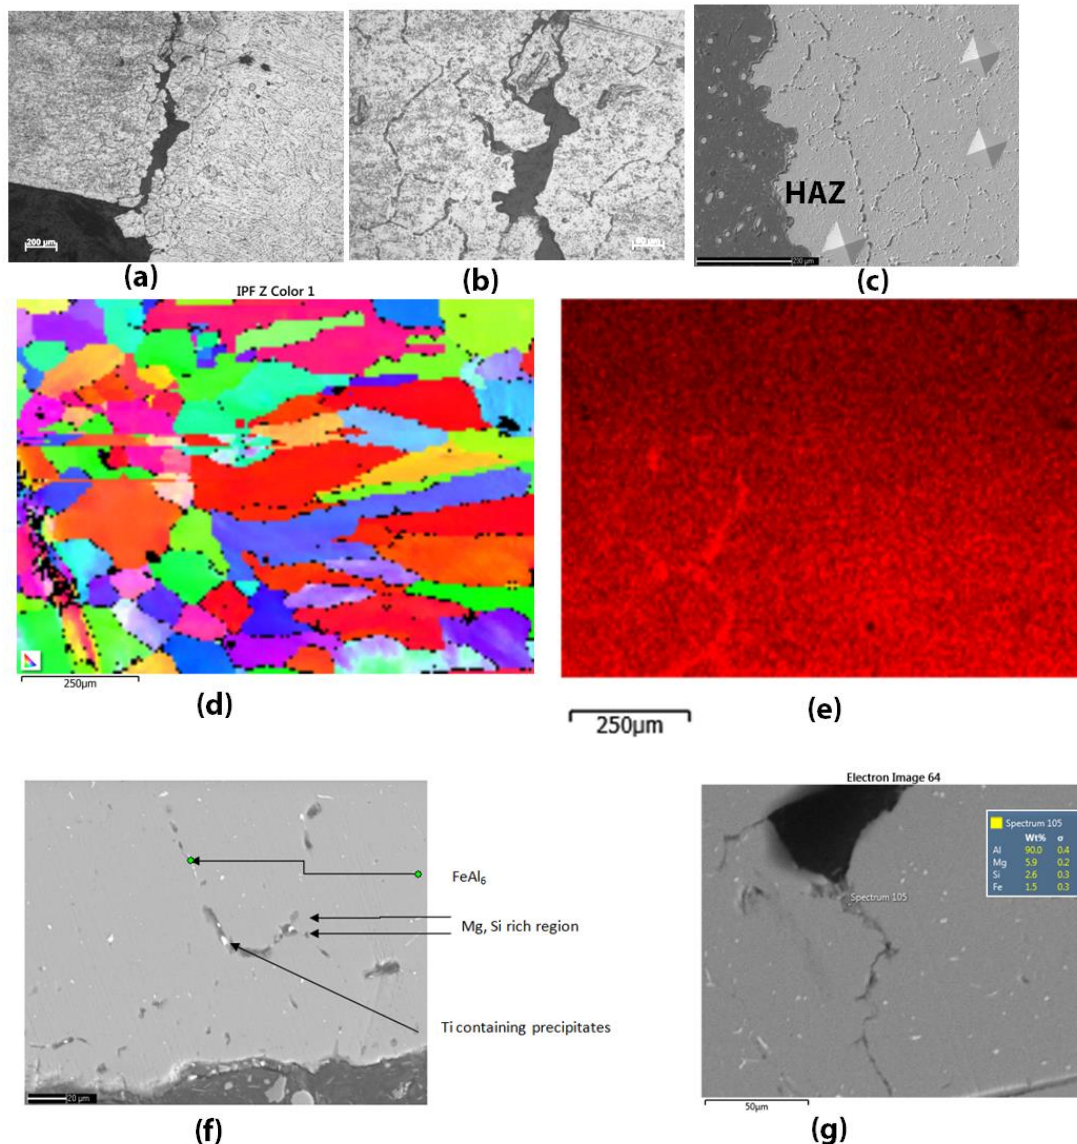
The optical micrograph of the transverse section at the crack location is shown in Fig.5 a and b. The micrograph shows that the nature of the crack is intergranular. The SEM micrograph of the heat affected zone in

the etched condition is shown in Fig.5c. It shows the presence of precipitates at the grain boundary near the cracked surface. As one moves towards the base metal, the extent of precipitate decoration at the grain boundaries reduces. The micro-hardness profile across the weld, HAZ and base metal indicates peak hardness at the HAZ location, just near weld (HV 60) and EDS analysis indicates Mg concentration of approximately 2.4 wt.% in the HAZ.

**Fig 5. (a) Optical Micrograph of cracked weld assembly of Al-2.1 wt.% Mg alloy indicates presence of cracks at HAZ location and (b) Higher magnification image indicates Intergranular nature of the crack, (c) SEM micrograph of HAZ region after etching showing grain boundary decoration, extent of decoration reduces towards base metal (d) Inverse pole figure map (IPF-Z) obtained from EBSD at transverse section of good Al-2.1 wt.% Mg tube tie plate weld joint. (The color code represents orientation of grains along the z direction), the black dot regions are of second phase precipitates which are mostly present at grain boundaries (e) The Mg K $\alpha$ 1\_2 image mapping obtained from same location using EDS indicates Mg rich region at the grain boundary just at the HAZ location near weld (f) SEM BSE image of some micro-cracks along with different phases, (g) High magnification BSE image of tight portion of the crack having high amount of Mg, Si, Fe rich phase.**

Figure 5d shows the results of EBSD analysis of a weld sample, which did not reveal through and through cracking. The EBSD inverse pole figure normal to the sample surface (IPF-Z) in the cubic stereographic projection of the transverse section of the weld between the thin tube and tie-plate shows crystallographic

orientations of different grains at the weld and HAZ regions (Fig.5.d). The columnar grain structure with aspect ratio 5 in the weld along with the presence of black spot (un-indexed) at grain boundaries which are mostly from second phase precipitates are seen. Presence of the grain boundary decoration with the black spot is significant at HAZ location. The grains at the HAZ locations are equiaxed and coarse. The simultaneous EDS count indicates that the grain boundaries of HAZ region are rich in Mg (Fig.5e), although complete decoration of grain boundaries with precipitates is absent in the good weld.

SEM micrographs of the as-polished cracked sample in the backscattered mode are given in Fig.5 f-g. The micrograph (Fig. 5f) indicates presence of precipitates of different morphologies, some appear dull whereas others are bright colored and needle shaped in back scattered mode. SEM micrograph of tight crack along with the results of EDS analysis for the second phase precipitates present within the micro crack is given in Fig.5g. The result indicates that the precipitates are rich in Mg (6 wt. %), Si (2.6 wt. %) and Fe (1.5 wt.%).

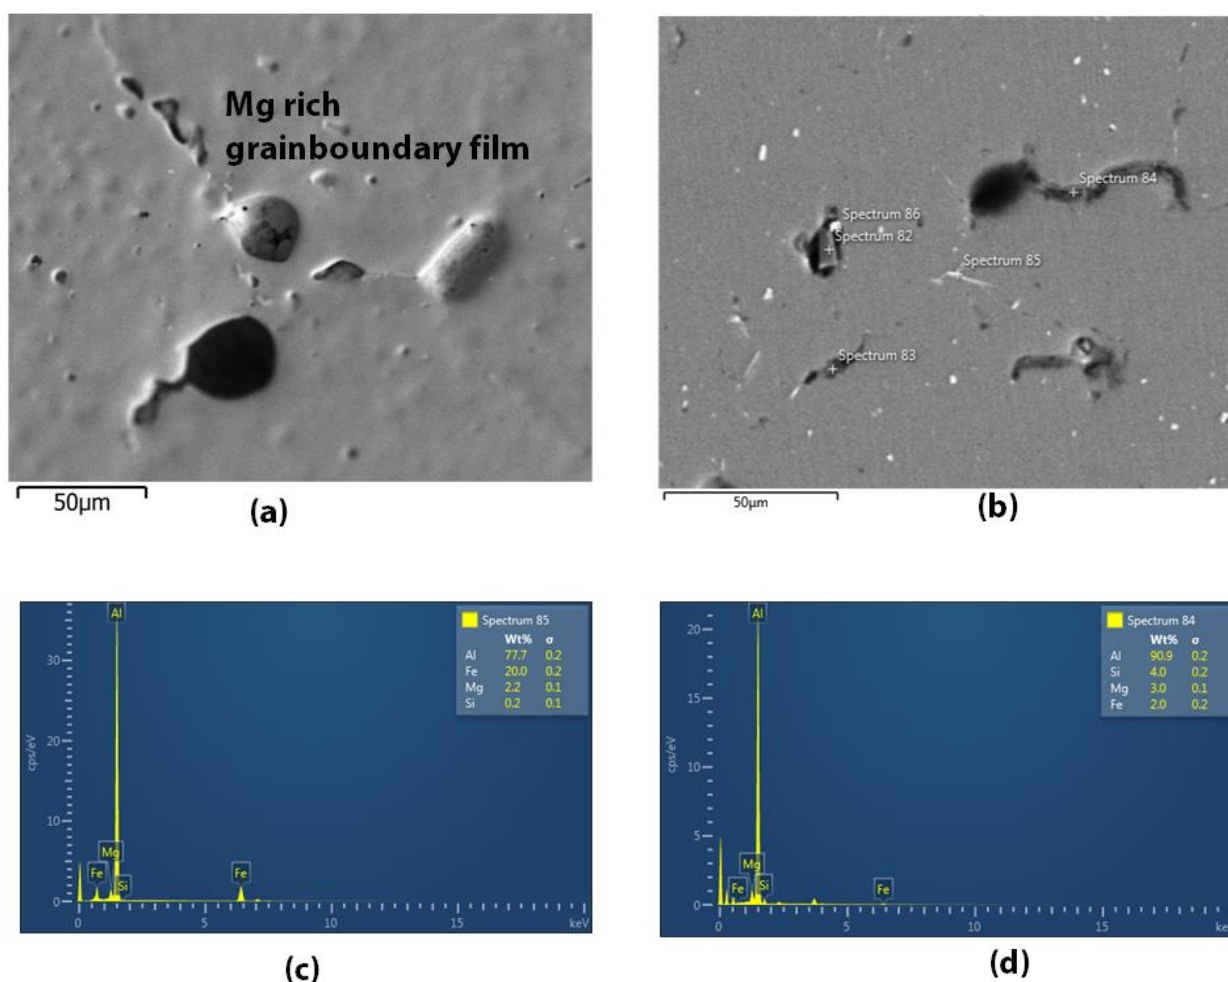
The morphology of typical grain boundary film which are rich in Mg are given in fig.6a. These film are associated to micro-cracks. EDS analysis of the needle shaped bright colour precipitate and the dull precipitate within the crack (Fig.6b), are given in Fig.6 c and Fig.6d respectively. The results of EDS analysis for the matrix near the crack location indicates Mg, in the range of 2.1 to 2.7 wt. % . The EDS result of needle shape bright colour precipitate shows that these precipitates are rich in Fe (10 to 25 wt.%) with some amount of Mg (2 to 2.8 wt.%) and Si (0.2 wt.%). From the morphology and the EDS analysis, these needle shaped precipitates are found to be of  $FeAl_6$  [30]. The EDS analysis (Fig.6d) for the dull phase present within the crack shows that the phase is rich in Mg (3 to 6 wt.%) and Si (3 to 7 wt.%) with some amount of Fe (1 to 2 wt.%).

**Fig.6(a)** SEM image of grain boundary film, **(b)** BSE image of as polished sample showing presence of different morphology of precipitates, **(c)** EDS analysis needle shape bright phase, **(d)** EDS analysis at the dull phase present at crack.

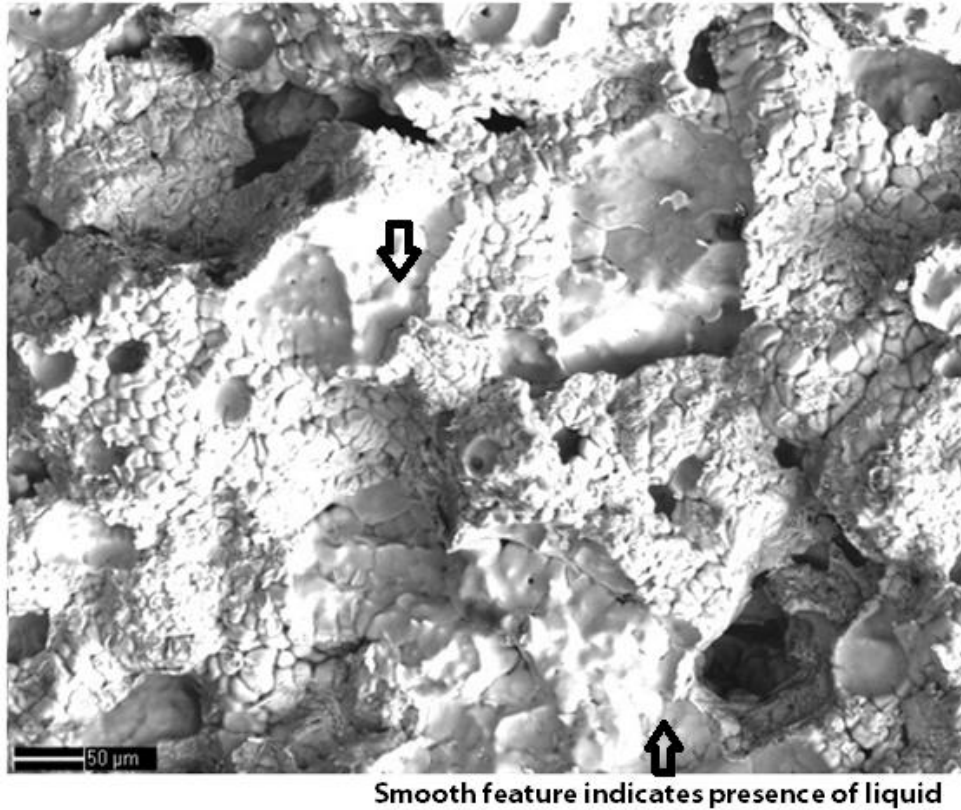
The crack face is observed under scanning electron microscope. The fracture surface (Fig.7) shows intergranular appearance and is characterized by the presence of smooth features, which indicates the presence of liquid at the time of fracture. The tip of the grains that are exposed to the fracture surface have ‘egg-crate’ appearance, which is typical of intergranular fracture. Table 3 shows the results of the EDS analysis carried out at 10 KV at the fractured surface and at 20 KV at the base metal. The table indicates that the fractured surface contains significantly higher concentration of Mg, Si and Fe as compared to the base metal.

**Fig. 7: Intergranular appearance of cracked face, seen under SEM**

Based on the results of the above investigations, it can be concluded that the low melting metastable phase comprising of Mg, Si and Fe was present at the grain boundary in the HAZ region. Fe is partitioned in the grain-boundary phase as it has poor solubility in Aluminium. It is also present as FeAl<sub>6</sub> within the grains. During welding, Mg from weld or matrix of HAZ, diffuse towards the grain boundaries and form low melting constituent. These grain-boundary precipitates grow like allotriomorphs under the influence of welding heat just near the weld region and decorate the entire grain boundaries. When the temperature in the HAZ just near fusion line reaches the liquidus temperature of the grain-boundary precipitate (during welding), liquation at the grain

boundary occurs because of the presence of low melting phase. However, the grains at the HAZ location are still in the solid state. During cooling, due to the presence of mechanically or thermally induced restraint, grains are separated along the grain boundary as the liquid film cannot withstand the tensile stresses. This leads to the formation of a crack in the heat affected zone.
