## Conservation of the Church and the Friary of “Santa Maria degli Angeli” in Atella (Potenza, Italy)

Received: 28 July 2017; Accepted: 2 October 2018; Available online: 25 November 2018

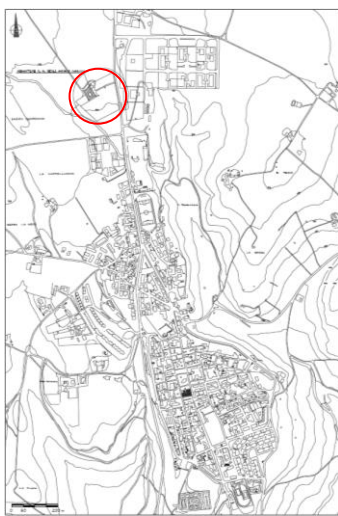
Figure 1: Church localization

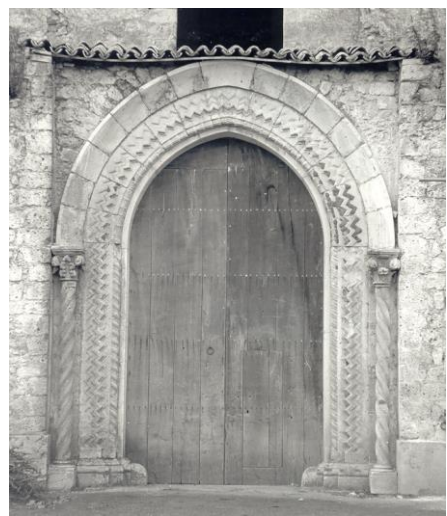
Figure 3: Lancet portal of the Friary

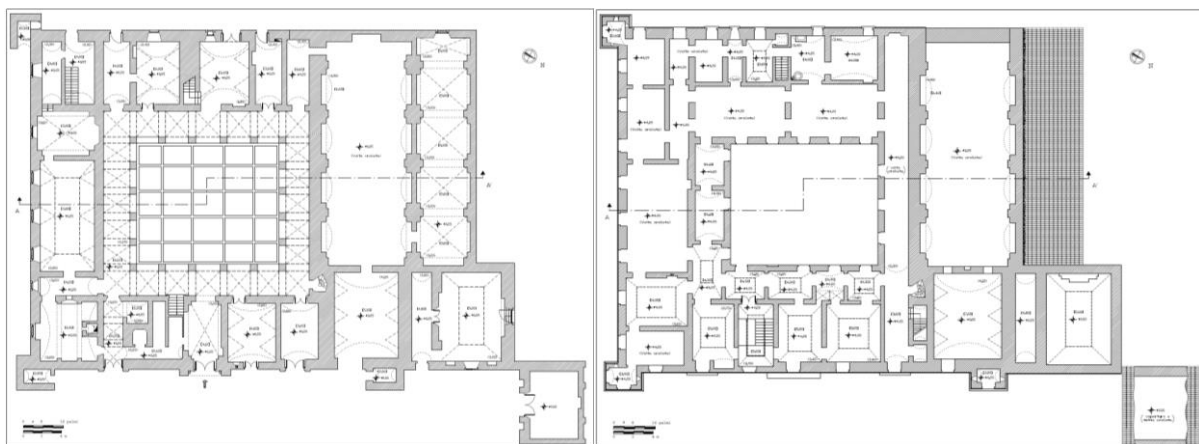
**Drawing 1:** Ground floor plan

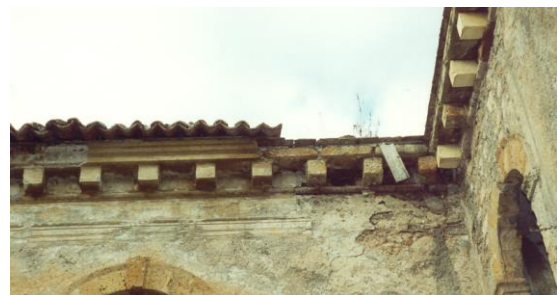
**Figure 9:** Detail of the cornice inside the cloister

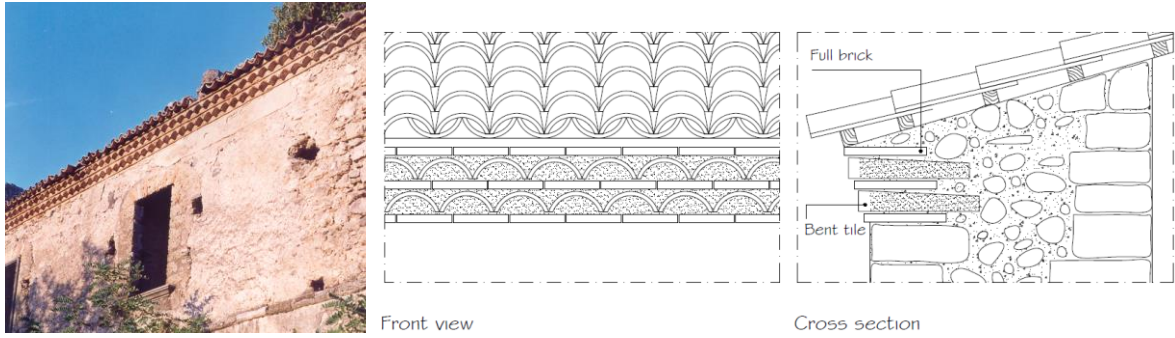
**Figure 10:** "Romanelle"

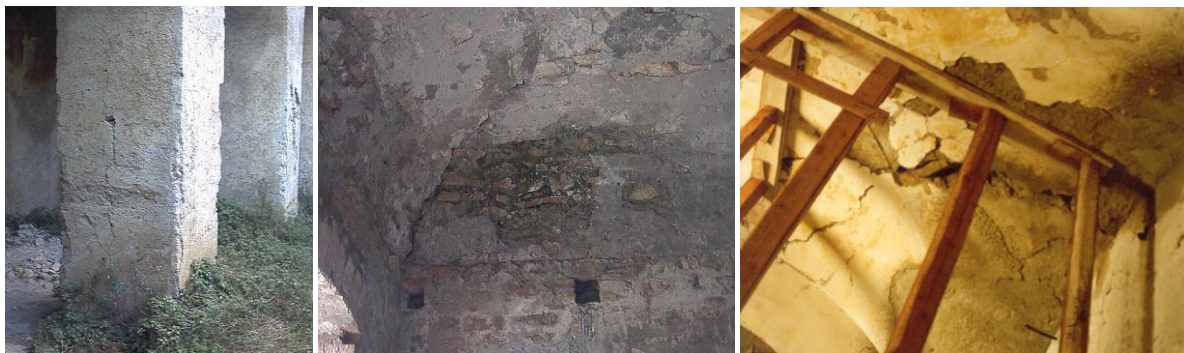
**Figure 13:** Degradation of the cloister's structures: pillar damaged by crushing (on the left); vaults remaining at the ground floor (in the center); vaults nearly collapsed (on the right)

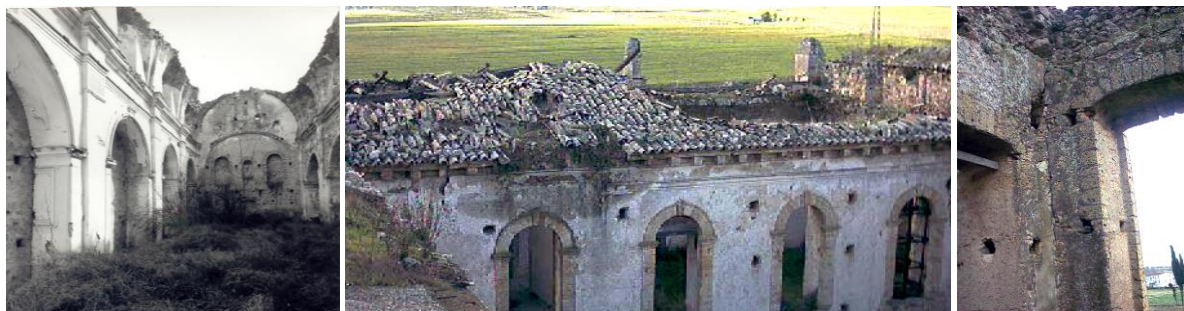
**Figure 14:** Conservation status of the Church of the Friary: internal view (on the left); ruins of ancient roofing, now collapsed (in the center); detachment of the internal walls from façade walls (on the right)

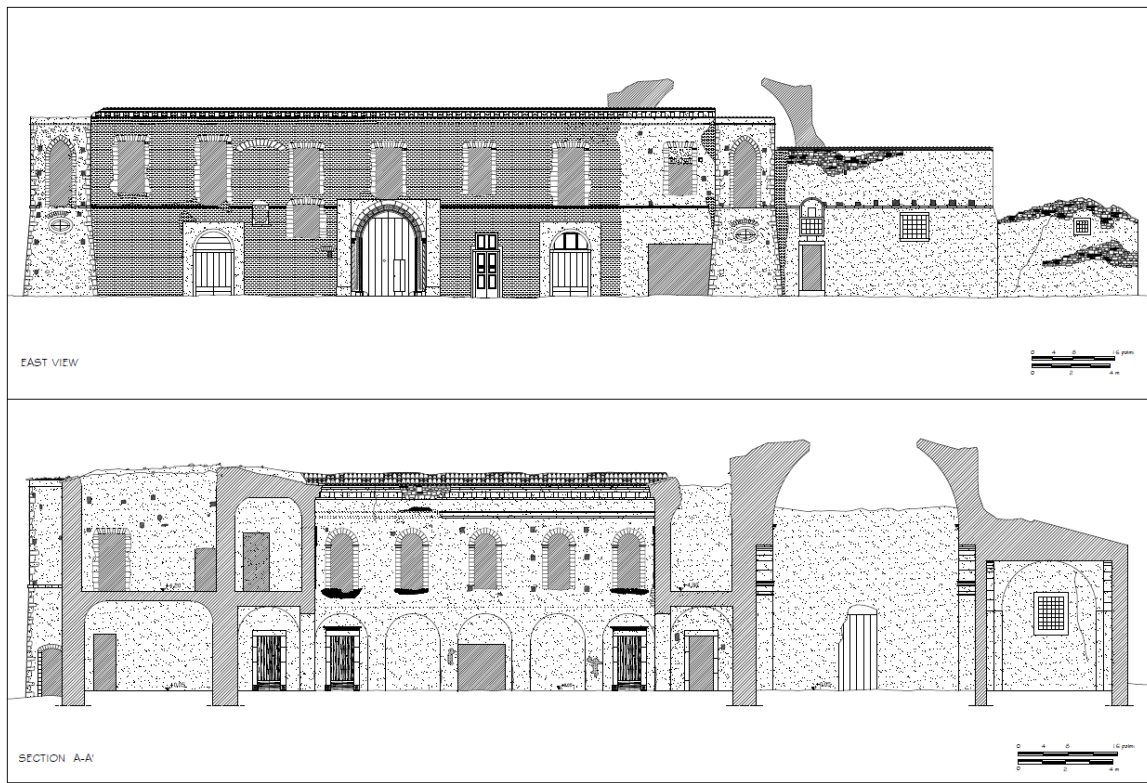
**Drawing 4:** East view and cross section

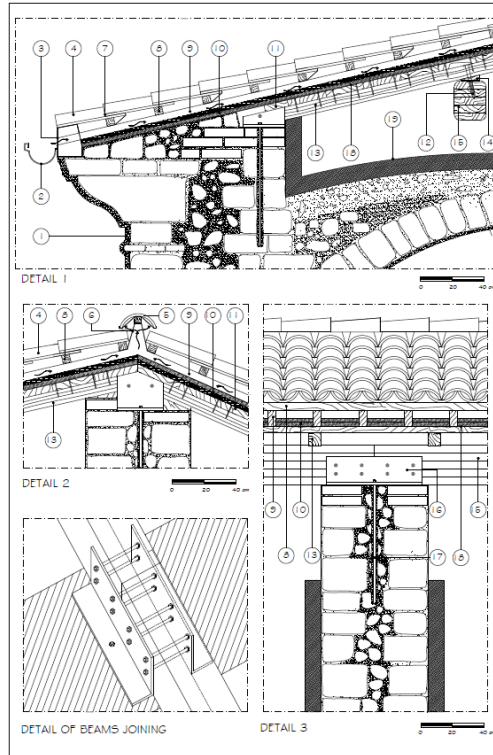
**Drawing 13:** Detail of roof in conditioned glued laminated Oakwood *Quercus Cerris* L.  
 (Legend: 1 - thermo-insulating render (40 mm); 2 - copper gutter (10/10 mm); 3 - copper mesh; 4 - bent tile; 5 - ridge cap; 6 - wood and copper ventilation element; 7 - copper fixing element for bent tile; 8 - counter batten (50 x 50 mm); 9 - batten (50 x 100 mm); 10 - cork insulating panels (30 + 30 mm thick); 11 - conditioned *Quercus Cerris* planks (40 mm thick); 12 - conditioned *Quercus Cerris* purlin (80 x 80 mm); 13 – conditioned glued laminated *Quercus Cerris* beam (200 x 250 mm); 14 - wedge; 15 – conditioned glued laminated *Quercus Cerris* beam (200 x 250 mm); 16 - stainless still beam base; 17 - stainless still improved bond bar (Ø 16 mm); 18 - non-vapor retardant roof underlay; 19 - vapor barrier glued to the vault and wall structure, and mineral wool insulation (10 cm thick)

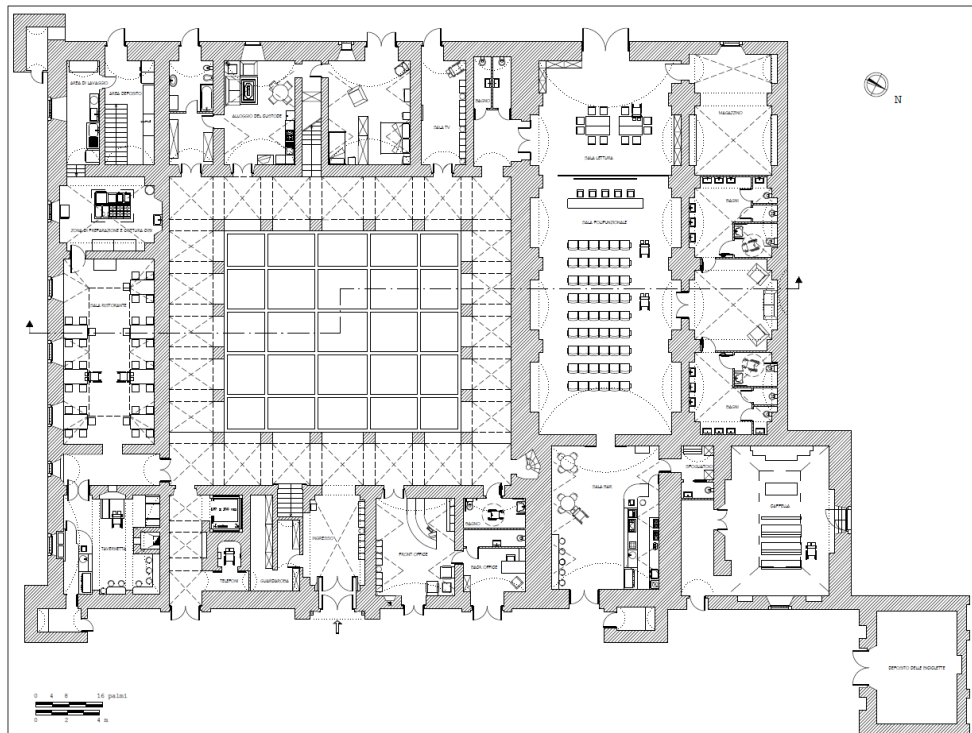
**Drawing 14:** Conservation design – Ground floor

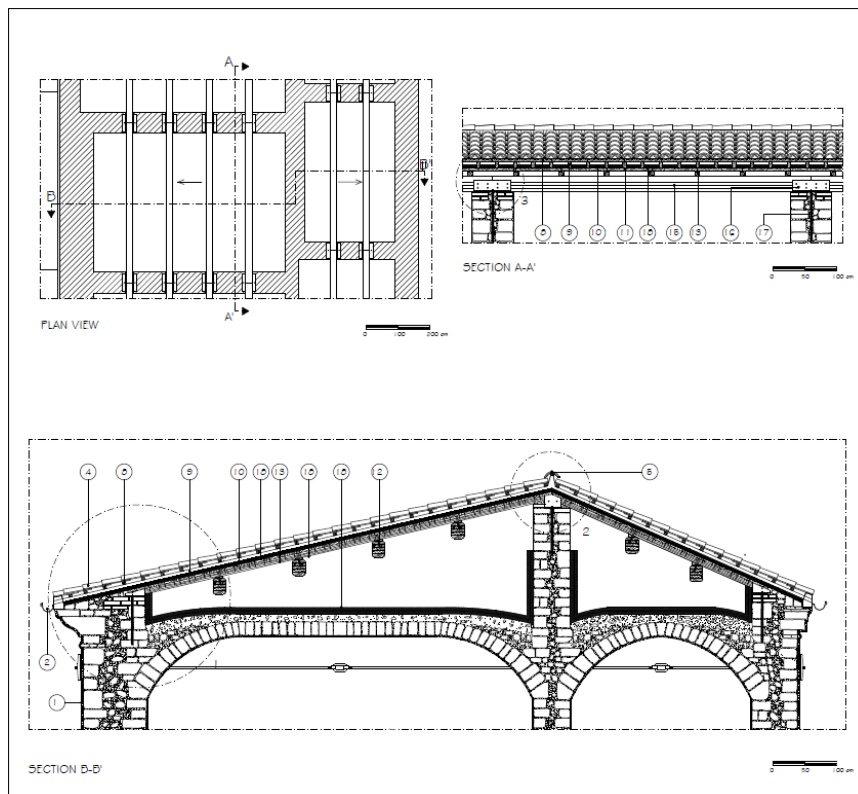
**Drawing 17:** Conservative design of typical roof

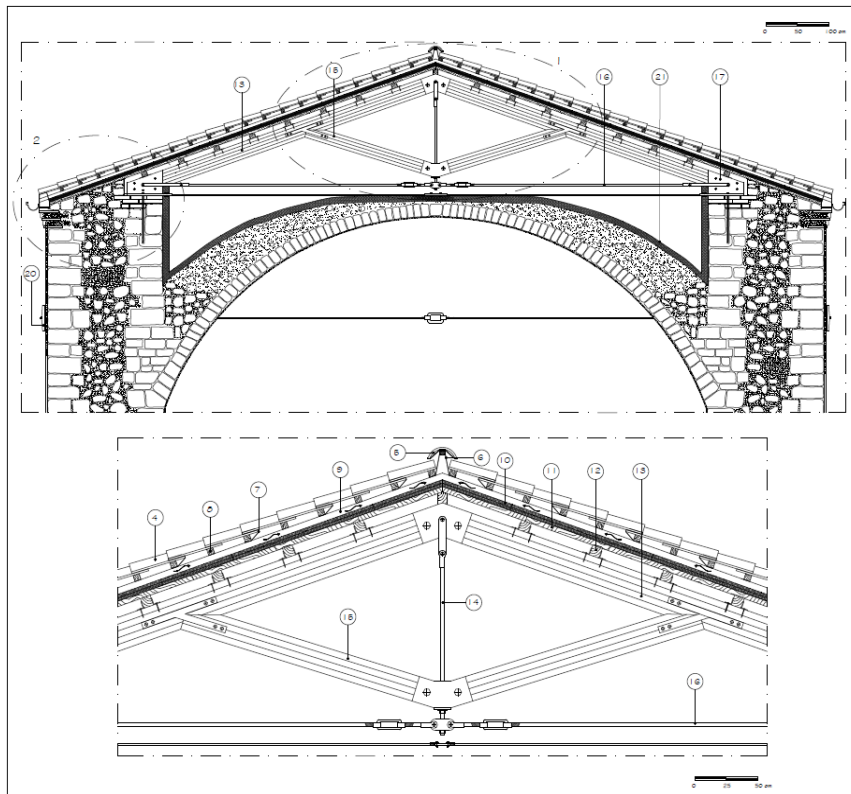
**Drawing 18:** Conservative design: roof on Church

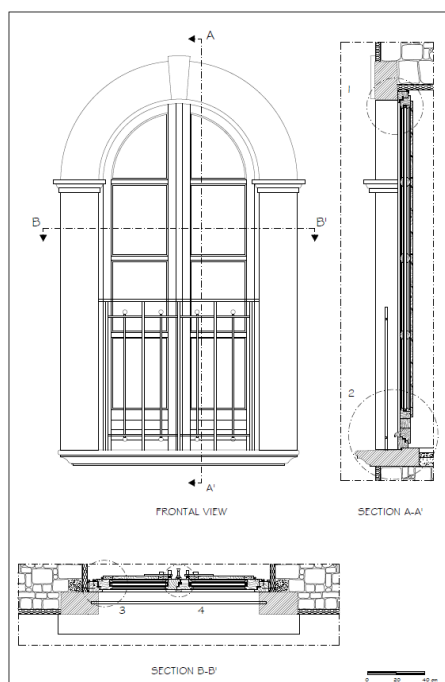
**Drawing 19:** Conservative design of new frames
