Brown Coal in Victoria, Australia and Maddingley Brown Coal Open Cut Mine Batter Stability

Lei Zhao, Greg You

School of Science, Engineering and Information Technology, Federation University Australia, University Drive, Mt Helen, Vic 3353, Australia

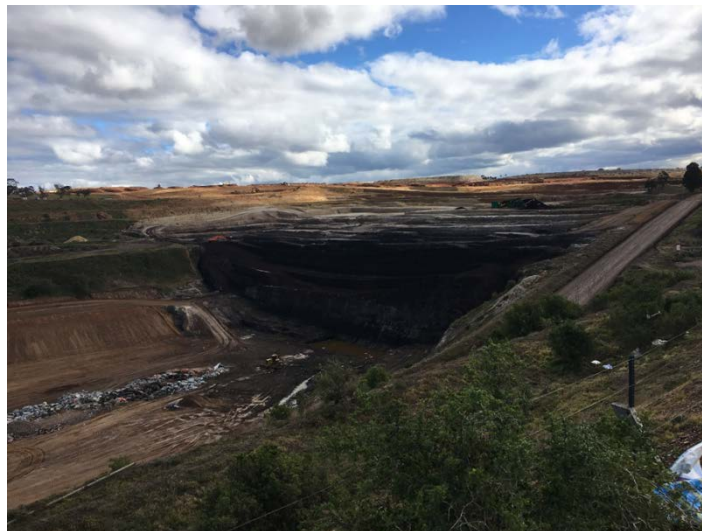
Figure 2. MBC north batter in August 2017

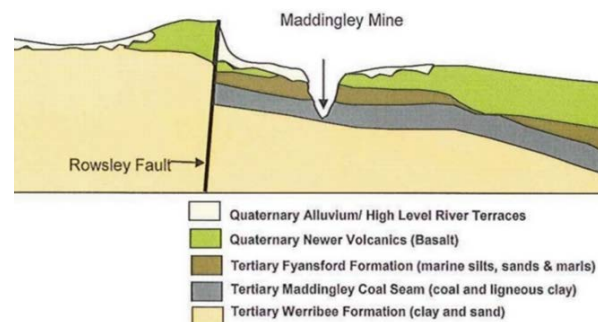
Figure 4. NW-SE Geological cross-section of MBC mine site, Bacchus Marsh, Australia [26]

aged sediments which were deposited as river terrace or alluvial river deposits. Quaternary basalt in the area belongs to the Newer Volcanic Group and was deposited across much of the Werribee Plains area as a sheet like lava flow. Sandy, silty and clayey gravels (predominantly sub-rounded quartz and quartzite gravel) of the Bullengarook gravels may also be found in the region overlying the Fyansford Formation and were deposited contemporaneously with the Newer Volcanic Group and can be found to interfinger with these basalt flows. Basement rocks in the region are considered to be Ordovician sediments and Devonian granodiorite rock [21]. The main geological units related to the site are shown in Figure 4.

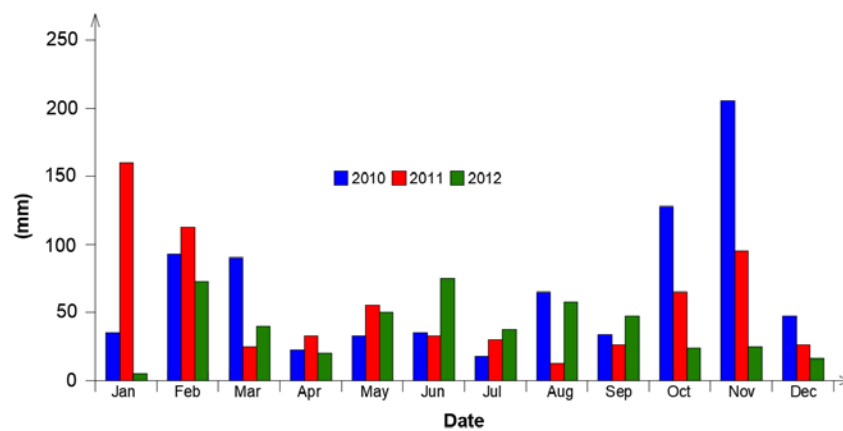
Figure 5. Monthly rainfall values (mm) for 2010, 2011 and 2012- Bacchus Marsh, Victoria

The regional groundwater flow is towards the north and northeast and the Werribee and Lerderderg Rivers. But in the mining area, it is affected by mine dewatering activities at site. The local groundwater flow in Fyansford Formation is towards Parwan Creek and the mined pit [21]. From the closest meteorology station at Merrimu, the mean monthly rainfall ranged from 40.0mm in January to 62.0mm in November from 1974 to 2012. The mean annual rainfall was 504mm. The monthly rainfall data from 2010 to 2012 is shown in Figure 5 [26].

On the other hand, it is interesting to note that batter failures are prone to occur in summer or close to summertime in Victoria. There is high precipitation in summer in Victoria, Australia. Figure 5 shows the distribution of precipitation in Bacchus Marsh from 2010 to 2012, where MBC mine site is located. Many reported Victorian Brown Coal batter slides or instability issues occurred not long after a rainfall event. A slip occurred in Yallourn north open pit in 1950 after a heavy rain [30]; one week after a rainfall a very large batter failure occurred at the northeast batter of the Yallourn East Field Mine on 14th November 2007 [33]; cracks were observed after a significant rainfall in Morwell Mine in February 2011 [31]; a brown coal embankment failed during an extreme rainfall at Gippsland in 2012 [32]; cracks manifested at the north batter in Maddingley Brown Coal open pit in November 2013, and further noticeable batter movements were observed after an intensive rainfall in February 2014 [37]. The rainfall related pit instability events almost concentrated in November and February when Victoria experienced the largest precipitations every year [33, 38]. There is a significant amount of rainfall throughout the year in Victoria, an average annual rainfall amount is between 1800-2500mm, with heavy downpours in summer months. The recorded highest rainfall in a single day was 375mm in the Otway Ranges in 1983 [39]. Therefore, rainfall is a notable factor which could cause batter instability in Victorian brown coal open pits, and a better understanding of the mechanism is helpful in predicting and managing the causal slope instabilities. However, there is no studies on the detailed analysis of the correlations between the stability of the Victorian Brown Coal open pits and rainfall event.

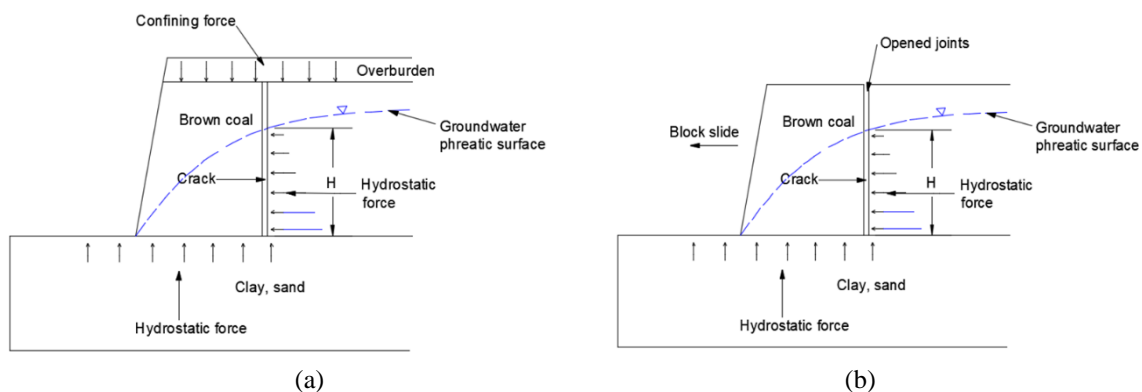
Figure 6. Victorian Brown Coal mine block sliding mechanism (a) with overburden (b) after overburden removal

Both geological structures and hydrogeology affect the batter stability in Victorian Brown Coal mines. From [30], the dip and strength of weak seams beneath coal, the orientation of joints, high level underground water and water pressure in joints were believed as the key factors to cause slope failure in Victorian brown coal open pits. The brown coal batter is a sandwiched geologic structure featured as a coal seam interbedded with silts, sands, and clays. In Victorian brown coal mines, batter movements and failures observed are characterized as circular sliding of overburden faces and block failure of brown coal faces [30, 35]. Corresponding to the low stripping ratio, most existing batters are brown coal faces, as a result, block sliding is likely the dominant failure type in Victoria brown coal mines. Block sliding is featured as a large block of brown coal slide horizontally towards the pit. Large movement of coal batter can occur due to low deformation modulus of brown coal after the open pit excavation, and it can lead to cracking in the coal seam. The opening up of coal joints increases the shear movements and rotations. The block sliding mechanism is shown in Figure 6.

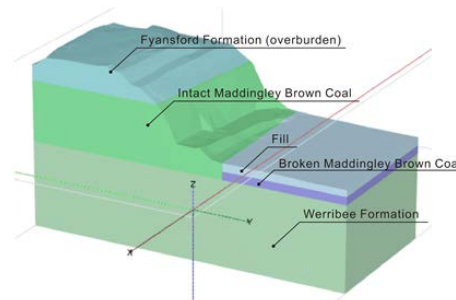
Figure 7. 3D geological model

Since 2016, the northern batter stability has been studied through three-dimensional finite element analysis using Plaxis3D. In the first phase of the project study, a three-dimensional geological model of north batter was constructed using the survey map in June 2012, which was 200m long, 100m wide and 109m high (Fig. 7). The groundwater was set at RL 91m in the north and at RL 60m at the pit bottom, flowing from the north to the pit bottom [40]. The finite element study is a fully coupled flow-deformation analyses to calculate the simultaneous development of deformation and pore pressures in saturated and partially saturated soils as a result of changes of the mechanical and hydraulic conditions. The numerical simulation processes include five stages, which are initial gravity loading, overburden removal, 21 mm rainfall, 7.6 mm rainfall and buttress model. Each stage includes two phases, e.g. defining the geomechanics and hydraulic state of the stage and calculating the factor of safety.

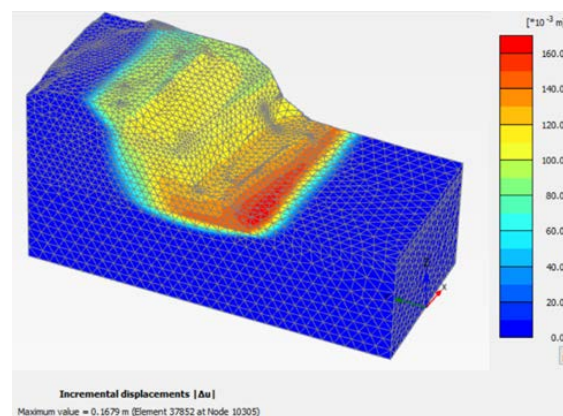
Figure 8. Simulated displacement of the overburden batter (Stage 1)

From the study, it was found that the overburden batter (Stage 1 model) tended to develop a circular critical path, e.g. potential circular failure when safety factor declines (refer to Fig. 8) and that the brown coal batter (Stage 2 model) tended to develop an "L-shaped" path, e.g. potential block failure when safety factor declines (refer to Fig. 9). The simulated safety factor was 1.4 for the batter with overburden and 1.2 for the batter after stripping

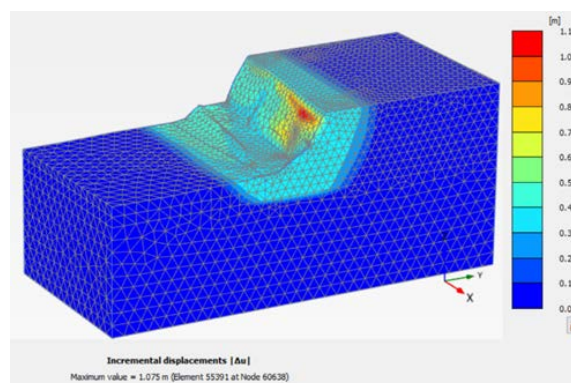
Figure 9. Simulated displacement of the brown coal batter (Stage 2 Overburden removal)

overburden. From the simulation, a maximum value ($\Delta\epsilon_{yy} = 0.34$) of incremental Cartesian normal strain was generated on the part where cracks appeared after overburden removal, while the value was less than 0.06 in other parts of the model. This advised that the cracks were the results of tensile failure and were mainly attributed to the overburden removal. To be specific, a confining force from the weight of overburden, bonding coal layer and overburden, weakened with overburden stripping, which decreased the batter stability. The location of the maximum strain was about 20m from the batter crest in the model that was well agreed with the actual location of cracks. From the study, the groundwater flow assisted in worsening the movement of the batter. The coal seam heaved 0.22m after overburden removal. This was in a line with the experience in Victoria open pit brown coal mines (A removal of 10m thick overburden could generate a heave of about 0.15m.) [37]. Considering the 21 mm/day rainfall event on 13 November 2013 the safety factor of the coal batter dropped from 1.2 to 1.1. This was mainly due to the extra driving force towards the pit caused by the water entering the cracks. The emergency buttress effectively strengthened the stability of north batter, and the safety factor was increased to 1.43 [38].
