Seismic Collapsing Process Analysis of One-story Thatched Roof Wooden Structure under Strong Earthquake Ground Motion

Tomiya Takatani¹, Hayato Nishikawa²

1. Dept. of Civil Engrg. & Architecture, Nat'l Institute of Tech., Maizuru College, Japan

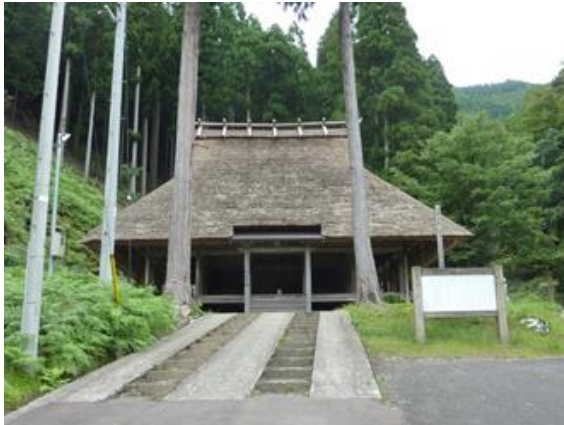
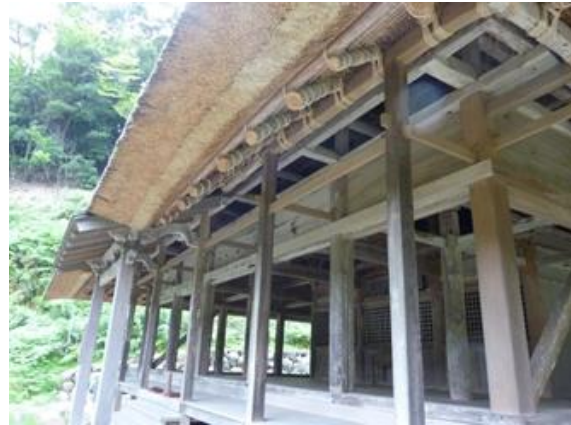
Photo 1 One-story wooden structure with thatched roof, “Yakushi-doh”

Photo 1 shows one-story wooden structure with thatched roof, Yakushi-doh structure, which was built an old Japanese traditional framed-construction method and have a thatched roof instead of tile. Yakushi-doh structure was dedicated in 1617 to deify "Bhaisajyaguru", who has been believed in a Buddha able to cure all ills, and has been an important cultural asset. Figure 1 indicates floor plan, elevation one, and cross section ones of Yakushi-doh structure. The width, depth, and height of Yakushi-doh structure are 13.211m, 11.756m and 10.254m, respectively. Photo 2 shows a post erected on a foundation stone under Yakushi-doh structure floor. There are many posts erected on their foundation stones with flat plane under Yakushi-doh structure floor, and they are not fixed on their foundation stones. Consequently, this system is likely to be a seismic base isolation. In this paper, the effect of the post fixing condition under wooden structure floor on seismic response of Yakushi-doh

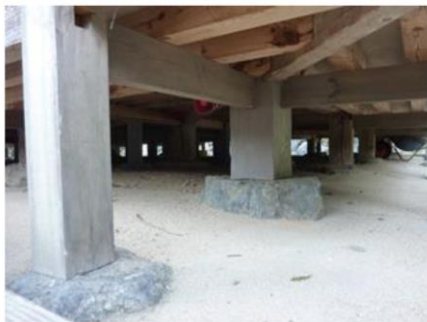
Photo 2 Post erected on a foundation stone

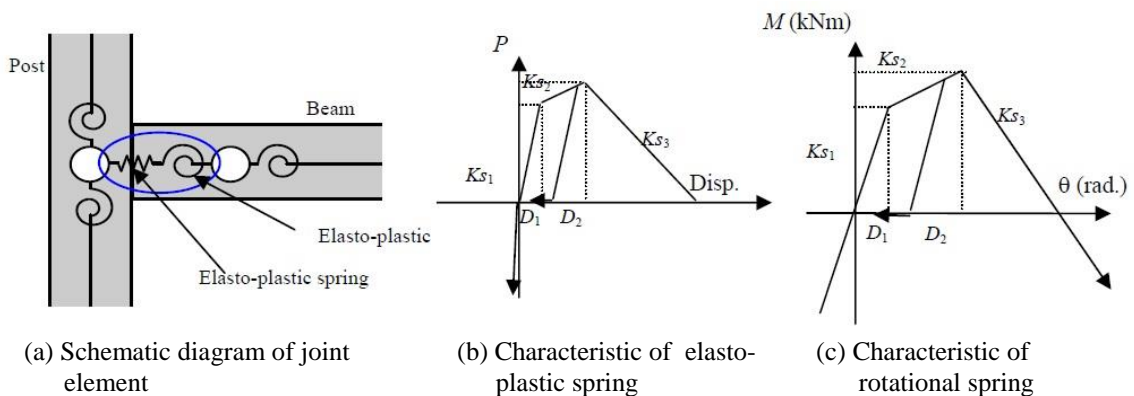
Figure 5 Outline of joint modelling [6]

Joint spring can be modelled by both an elasto-plastic spring and a rotational spring as shown in Figure 5(a). Timber characteristic of the compression and tensile elasto-plastic spring consist of an elastic part and slip-type part indicated in Figure 5(b), and also timber characteristics of the rotational spring is assumed to be a slip-type relationship between ending moment M and angle of rotation θ shown in Figure 5 (c). When the elasto-plastic spring or the rotational spring of the joint exceeds the maximum structural strength or moment and their strength values becomes 0, the joint will be adjudged to have been broken and then the spring will be annihilated.

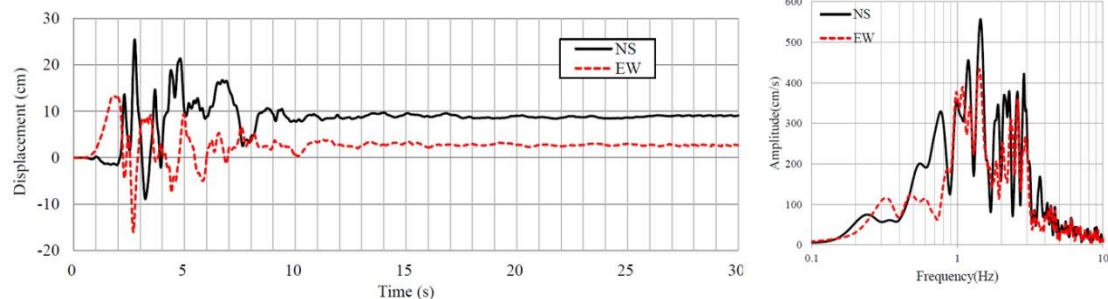
Figure 9 Displacement waves and Fourier acceleration spectra of the JMA Kobe wave

Figures 9 and 10 indicate two displacement wave data and their Fourier acceleration spectra for both NS and EW components in each earthquake ground motion record shown in Table 4. In the JMA Kobe wave record indicated in Figure 9, a peak frequency in each wave component is from 1Hz to 1.5Hz, and also a peak in each wave component of the JR Takatori wave record illustrated in Figure 10 exists about 0.8Hz. Because there are peak frequencies in both the JMA Kobe and the JR Takatori wave records in the frequency range of 0.5 to 1.5Hz, their wave records seem to cause severe damage in the collapsing analysis of an old wooden structure against a strong earthquake ground motion as reported by Sakai *et al.* [7].
